Building Assessment

Residence at Fish Creek Beach

Fish Creek, Wisconsin

GIBRA 141976

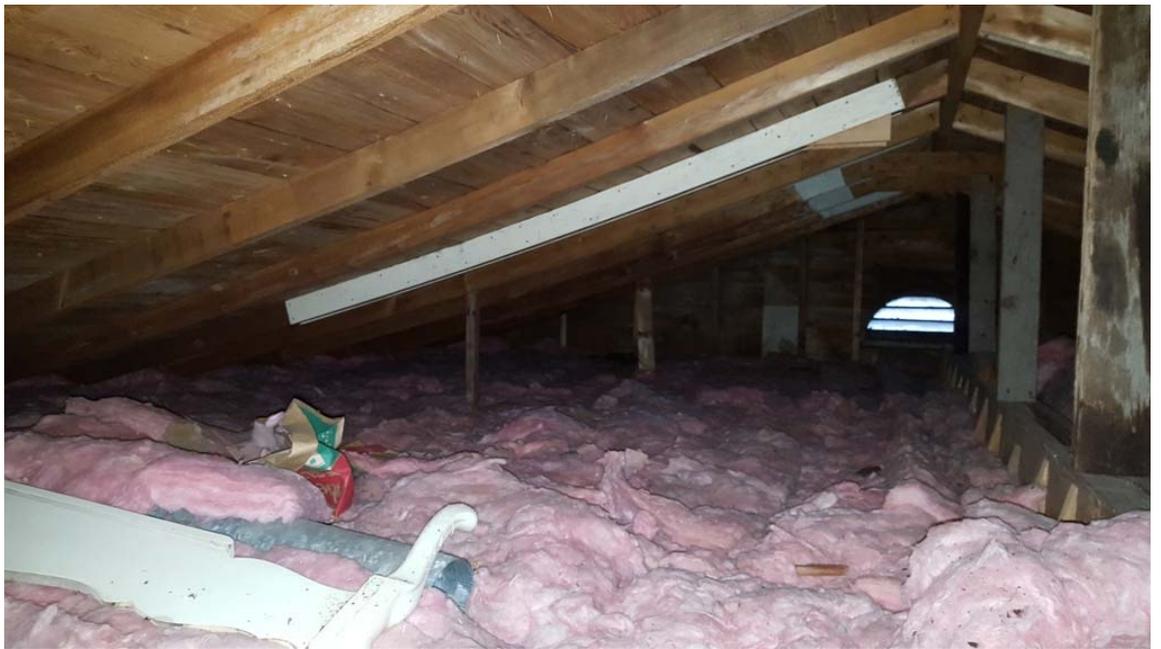
Attic

The original building roof is hand framed with wood rafters. There does appear to be a slight sag in the roof along the ridge line and there has been some reinforcing efforts made in the attic to support or repair the roof over the years.

The only insulation observed during inspection was in the attic space of the original building. Floor system in newer addition is not insulated and it is likely that there is no insulation in building's original walls or floor. As it is believed that this has been used as a seasonal residence, insulation may not have been a concern to building owners.

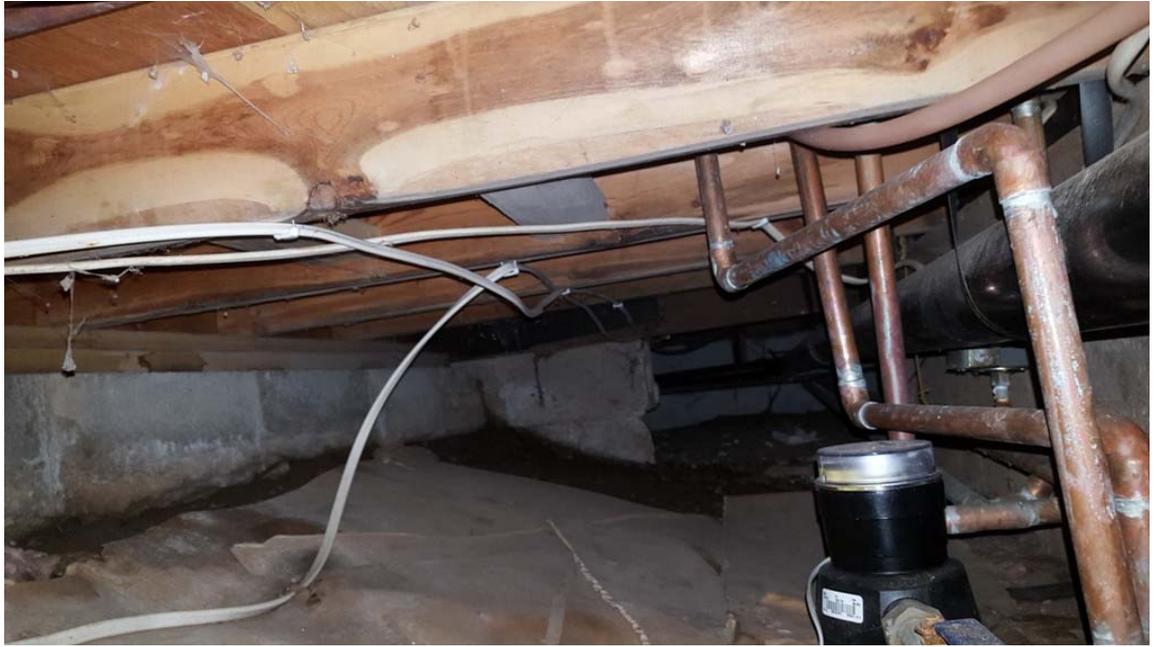
Crawl Space Below Addition

The building is a typical wood framed residential structure. The original section of the building is set on a field stone foundation over a minimal crawl space. The remainder of additions are constructed on a concrete block perimeter foundation wall with a shallow crawl space that is accessible via an access panel located in the utility room of the master bedroom addition.

The overall condition of the building structure is in good condition, however the condition of the floor joists below the existing building could not be verified.
